April 2008

As if by magic ...

Peter Berger (dental technician), Germany

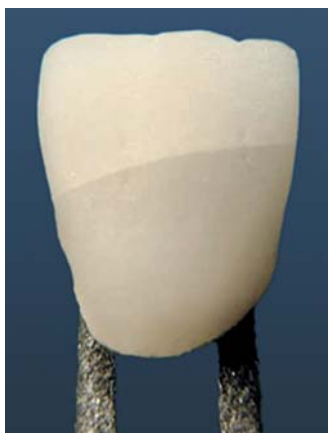
A seriously cracked crown.

We took a ceramic crown, still searing hot, directly out of the ceramic furnace, and shock-sprayed it with cold spray. An ominous cracking sound signaled the presence of numerous fissures – truly a case for the bin. We then applied a thin coat of Denseo Fairy and performed a healing firing. The result after ten minutes was that the material had been seamlessly re-joined. No more cracks were visible even under the microscope, not even after abrasive removal of the surface. This fairy is a reliable helper in a time of need! ■

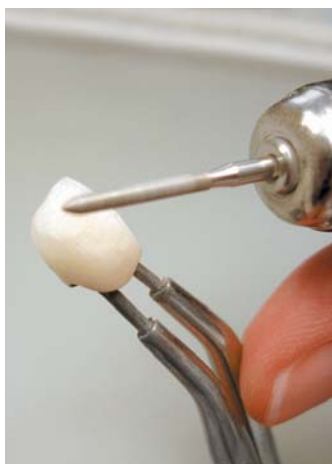
Grinding the crown.

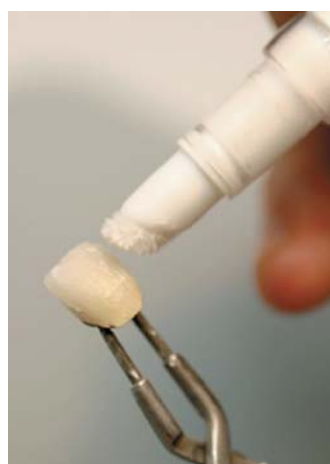
Applying Denseo Fairy.

Looking around for a solution to this problem, I discovered a fairy – Denseo Fairy. Denseo Fairy is a new product that you paint on the cracked crown, which is then subjected to a “healer firing” in the furnace. A vacuum is first created in the furnace to make sure the Denseo material deeply penetrates the crack and any ramifying microcracks. Independent of the ceramic material and alloy used, the “healer firing” is always performed at a constant temperature, which is lower than that for glaze firing. The manufacturer of Denseo states that the ceramic material on both sides of the crack will be rejoined at a molecular level. We wanted to be completely sure, so we put Denseo Fairy to a very challenging test.

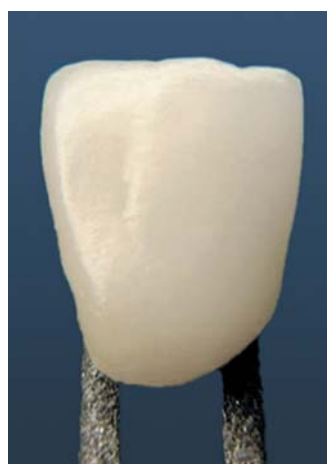
After firing. No more cracks.
